NATIONAL DAM SAFETY PROGRAM. LEMBECK LAKE DAM (MO 30369), MISSI--ETC(U)

LEMBECK LAKE DAM  
JEFFERSON COUNTY, MISSOURI  
MO. 30369

**PHASE I INSPECTION REPORT  
NATIONAL DAM SAFETY PROGRAM**

PREPARED BY: U. S. ARMY ENGINEER DISTRICT, ST. LOUIS

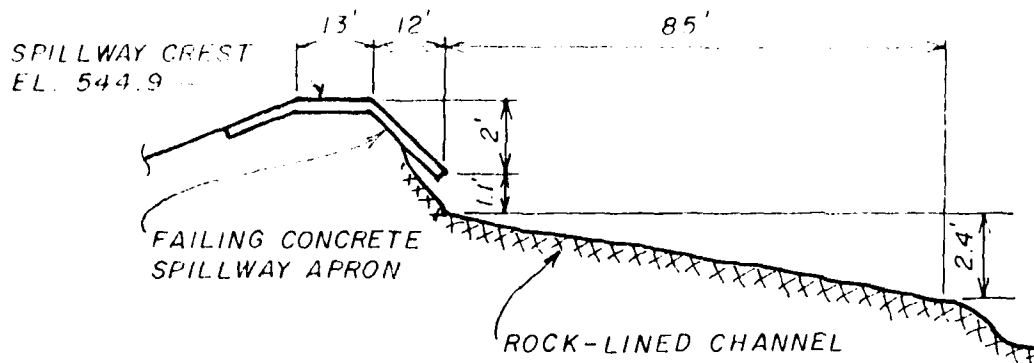
SECTION A-A  
(SPILLWAY PROFILE)

There is only one spillway at this damsite which consists of a channel cut into the weathered bedrock of the left abutment. The control section of the spillway is a broad-crested weir 13 feet wide and 80 feet long that also serves as an access road which proceeds across the top of the dam (see Photos 5 and 6). The weir has a parabolic shape with the minimum crest elevation of 544.9 feet above M.S.L., which is the normal reservoir elevation. The weir is constructed of a three to four inch thick, nonreinforced, concrete slab placed on top of riprap. The sloping upstream and downstream aprons of the weir are also paved with concrete. The upstream apron is mostly covered by reservoir sediment. The downstream apron slopes downward from the weir crest to the spillway discharge channel with a three feet drop in elevation. Downstream of the weir the spillway discharge channel bottom is lined with weathered bedrock (see Photo 7). The left side slope of the channel is tree and brush covered. Remnants of a concrete retaining wall and grass and riprap covered embankment material comprise the right side slope of the channel (see Photo 9). The channel bottom is a series of ledges and chutes in the bedrock as the spillway proceeds downstream of the dam embankment and curves toward the downstream channel. Downstream of the dam embankment, the channel is aligned roughly parallel to the axis of the dam and is adjacent to a railroad

The bedrock-lined channel beginning just downstream of the broad-crested weir has undergone considerable erosion since the time of its construction (see Photo 7). This was evidenced by the remnants of a second weir that failed five years ago, according to Dr. Kang (see Photo 9). The bottom of this concrete weir that is still in place is perched two feet above the current channel bottom. The weir extended across the spillway channel slightly downstream of the dam axis. It is assumed that the bottom of the weir was set on the bedrock lining of the channel. It appears that the weir fractured near its right abutment. The majority of the structure was seen lying along the left edge of the spillway channel (see Photo 7).
